# Manhole Inspection Summary

Manhole # S21II\_038MH

Insp Date: **6/25/07 8:53 AM**

**Location** Address: **1641 WESTWOOD ST**

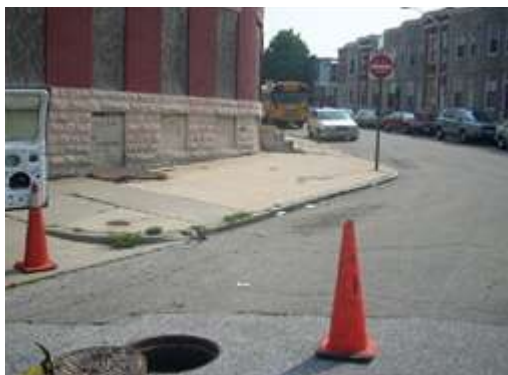
Location View

Offset: **3** (in.)

FRAME OFFSET

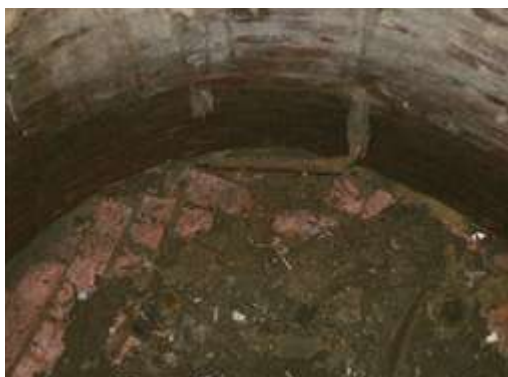
Defect 2

Count: **3** Missing: **2** ☒ **Corroded**

MISSING AND CORRODED STEPS

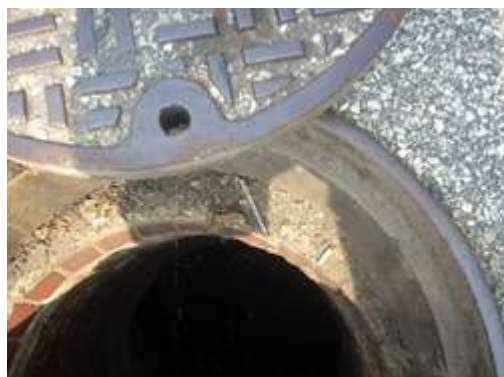
Defect 1

FRAME OFFSET

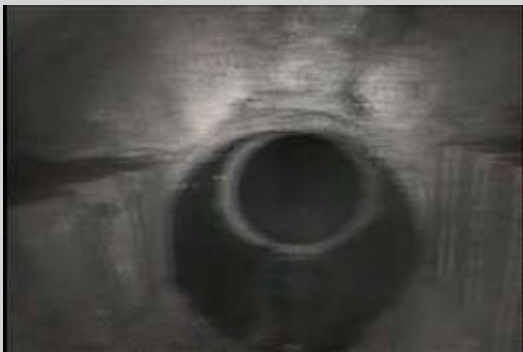
12 O'Clock Outflow

8 in. Circular Gravity Sewer  
Pipe Out @ 12 O'Clock

Pipe Height: **8.4** (in.) Rod and Bar (Angled)  
Pipe Material: **Clay** ☐ Pipe Lined  
Invert Depth: **9.69** (ft.) Flow Characteristics: **Slow**  
Deposits: ☒ None ☐ Mud ☐ Sludge ☐ Debris ☐ Grease  
Silt Depth: (in.) Deposits Extent:  
Infiltration: **None** Pipe Seal Cond: **Sound**

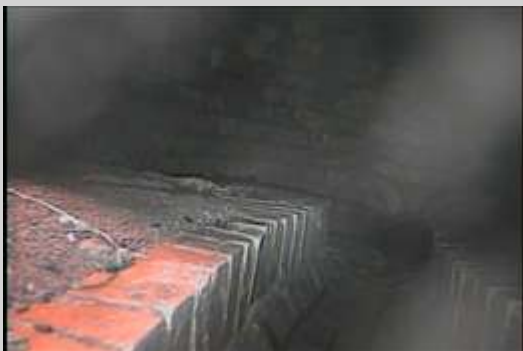
3 O'Clock Inflow

8 in. Circular Gravity Sewer  
Pipe In @ 3 O'Clock

Pipe Height: **7.2** (in.) Rod and Bar (Angled)  
Pipe Material: **Clay** ☐ Pipe Lined  
Invert Depth: **9.60** (ft.) Flow Characteristics: **Slow**  
Deposits: ☒ None ☐ Mud ☐ Sludge ☐ Debris ☐ Grease  
Silt Depth: (in.) Deposits Extent:  
Infiltration: **None** Pipe Seal Cond: **Sound**

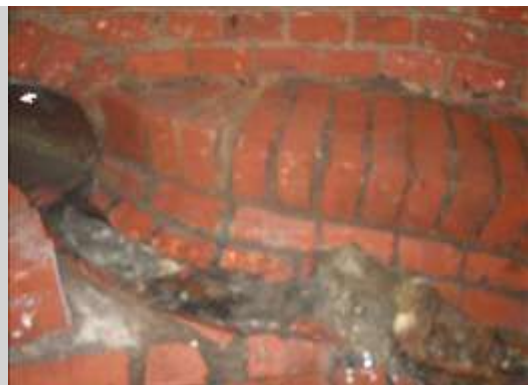
6 O'Clock Inflow

8 in. Circular Gravity Sewer

Pipe In @ 6 O'Clock

Pipe Height: **8.4** (in.) Rod and Bar (Angled)

Infiltration: **None** Pipe Seal Cond: **Sound**
